**DOT/FAA/AR-95/15**

# **Development of a D SIGHT Aircraft Inspection System: Phase II**

Final Report

1. Report No. DOT/FAA/AR-95/15 * TP 12470E		2. Government Accession No.		3. Recipient's Catalog No.	
4. Title and Subtitle  DEVELOPMENT OF A D SIGHT AIRCRAFT INSPECTION SYSTEM: PHASE II				5. Report Date  March 1996

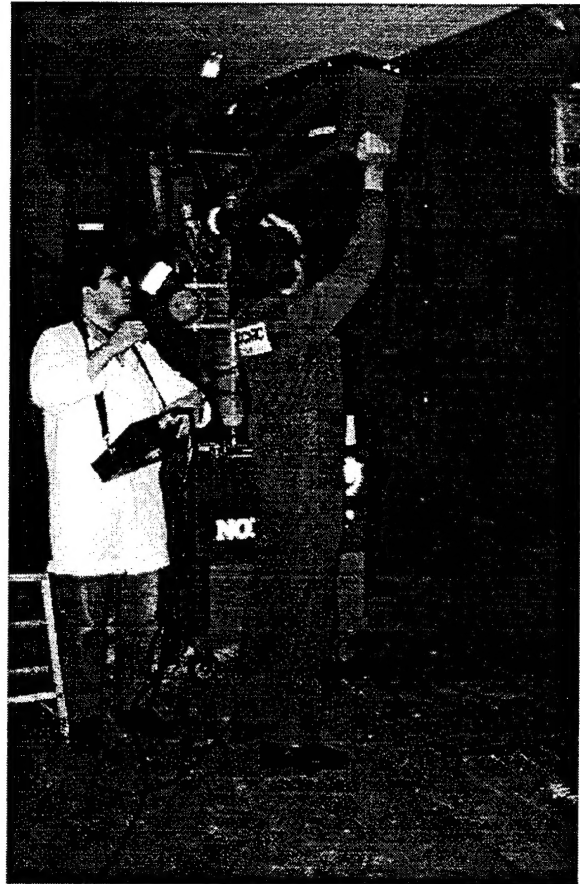
FIGURE 14. INSPECTING B-747 BELLY

The following figures (figures 13 to 21) show the new DAIS equipment being used at various facilities during the field trials. A few typical *D SIGHT* images of the aircraft surfaces are also shown at different corrosion levels (figure 15, figure 20, and figure 21).

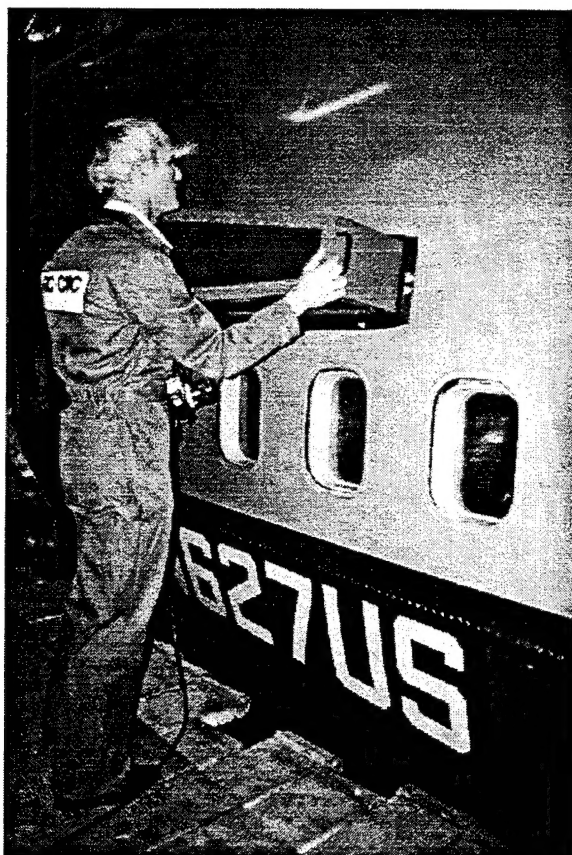
FIGURE 16. INSPECTING UPPER WINDOW BELT

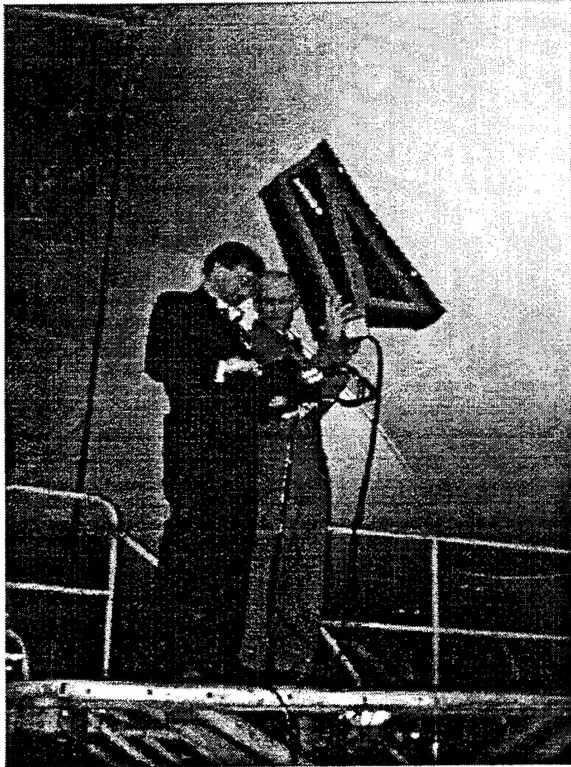
FIGURE 17. B-747 FUSELAGE INSPECTION

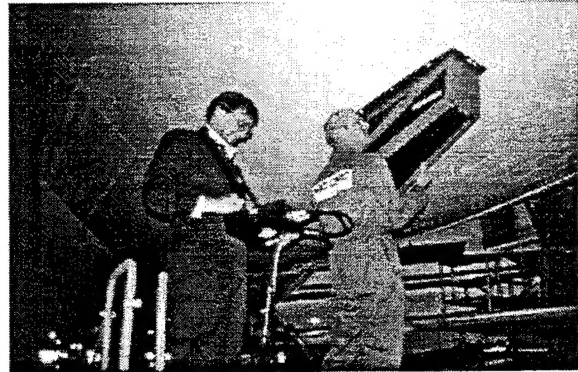
FIGURE 18. B-747 FORWARD BELLY INSPECTION

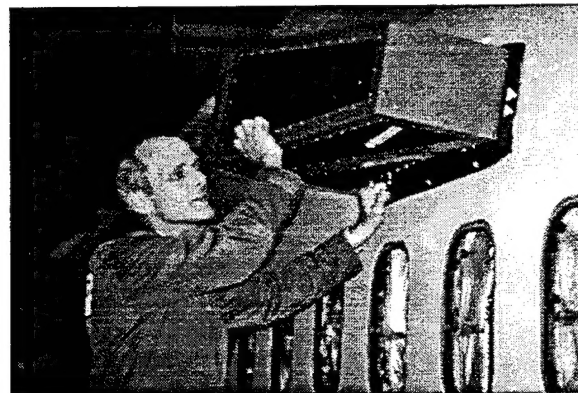
FIGURE 19. UPPER WINDOW BELT INSPECTION
